Electrospark Deposition for the Repair of Army Main Battle Tank Components

ARL-TR-3849

July 2006

**Victor Champagne, Marc Pepi, and Brian Edwards
Weapons and Materials Research Directorate, ARL**

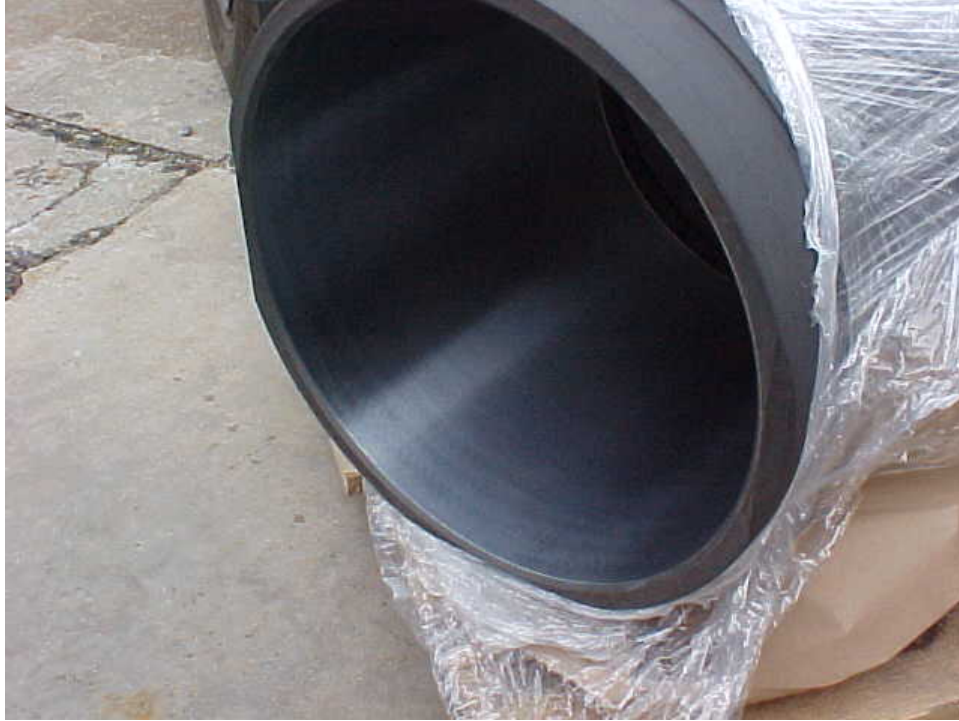
Figure 2. Cannon cradle disassembled from tank.

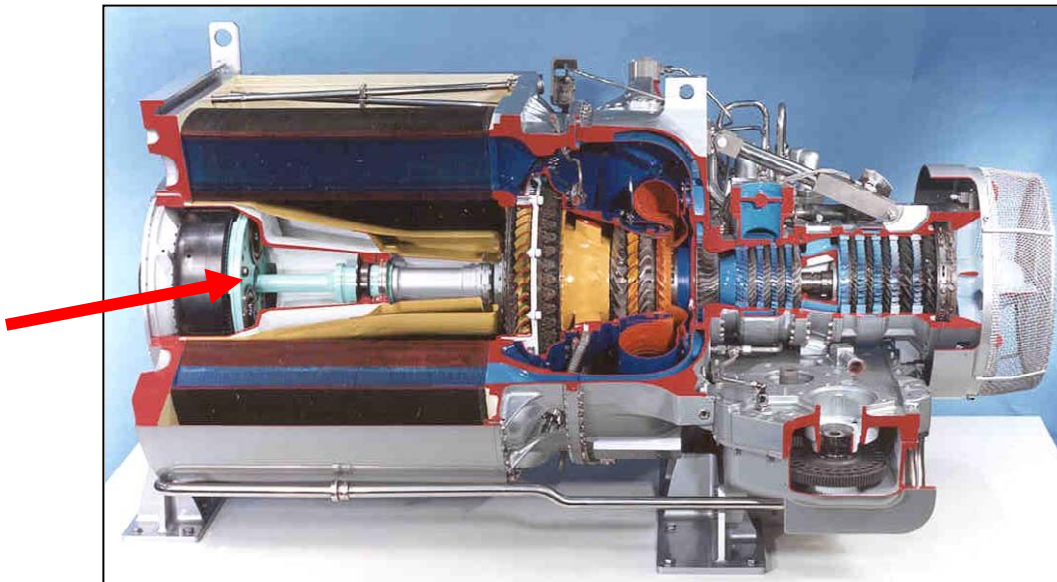
Figure 3. Arrow indicates location of the helical gear shaft within the M1A1 main battle tank AGT-1500 engine.

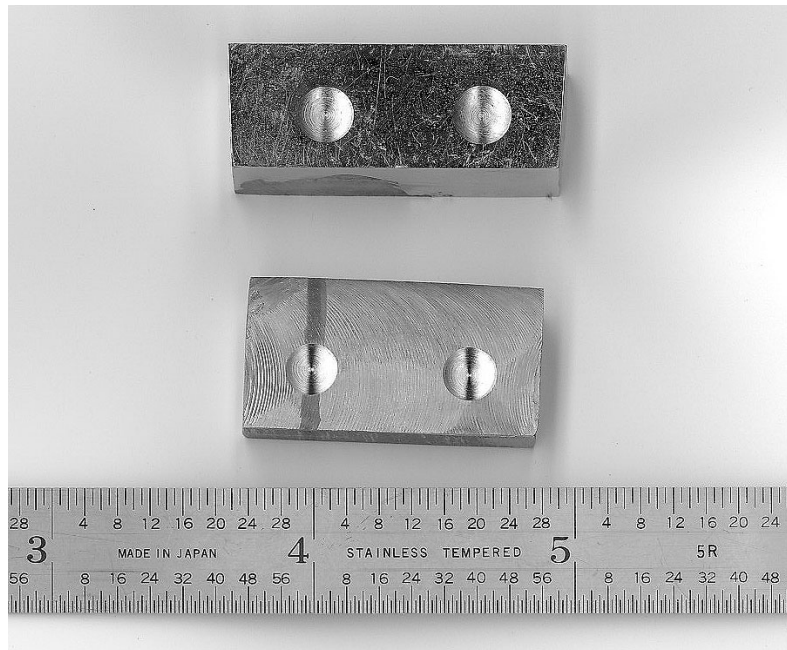
Figure 9. Test samples used for ESD process parameter optimization for the M1A1 helical gear shaft repair. Top block is chrome plated, and bottom block is uncoated AISI 9310 steel (magnified 1.5×).

The ESD repair procedure was developed and proved out at ARL for the gear shaft. Numerous ESD trials were conducted at ARL in order to determine the optimal set of process parameters that would result in a dense, adherent deposit. These trials were performed on coupons representing the material of the sun gear (chrome-plated AISI 9310 steel). Defects were machined into test samples (figure 9), and subsequently filled using ESD. Table 1 summarizes the iterative process utilized for each of the six defects, while figure 10 shows a representative scanning electron micrograph (SEM) of a section of each defect. Condition 4 was considered to exhibit the optimal coating characteristics and is highlighted in table 1.

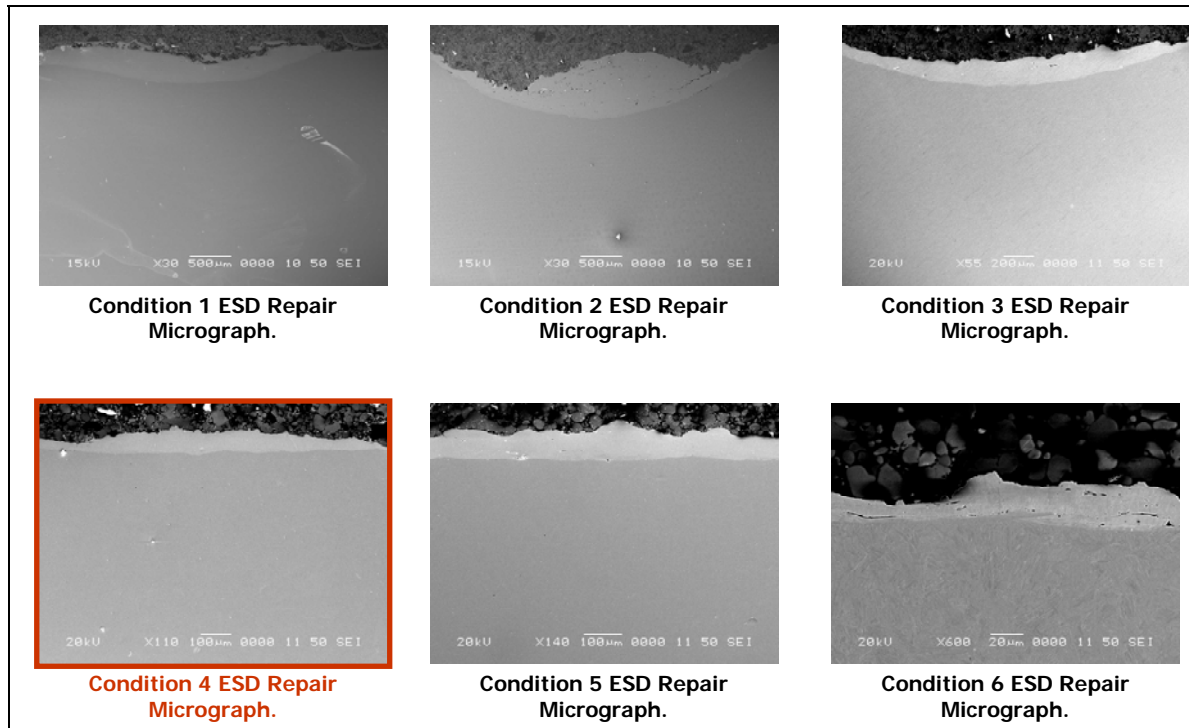
Figure 10. The ESD parameters chosen for condition 4 were selected as optimal.

The parameters used in condition 4 were chosen to be used for the repair of the helical gear shaft. These parameters were chosen for the uniformity and density of the coating, the clean interface between the coating and substrate, and the lack of voids and intergranular sites. Figure 11 shows an optical macrograph of two ESD-filled defects, as well as an unfilled defect, while figure 12 includes an SEM micrograph of the surface of condition 4. Figure 13 shows an SEM micrograph of a cross section of condition 4.

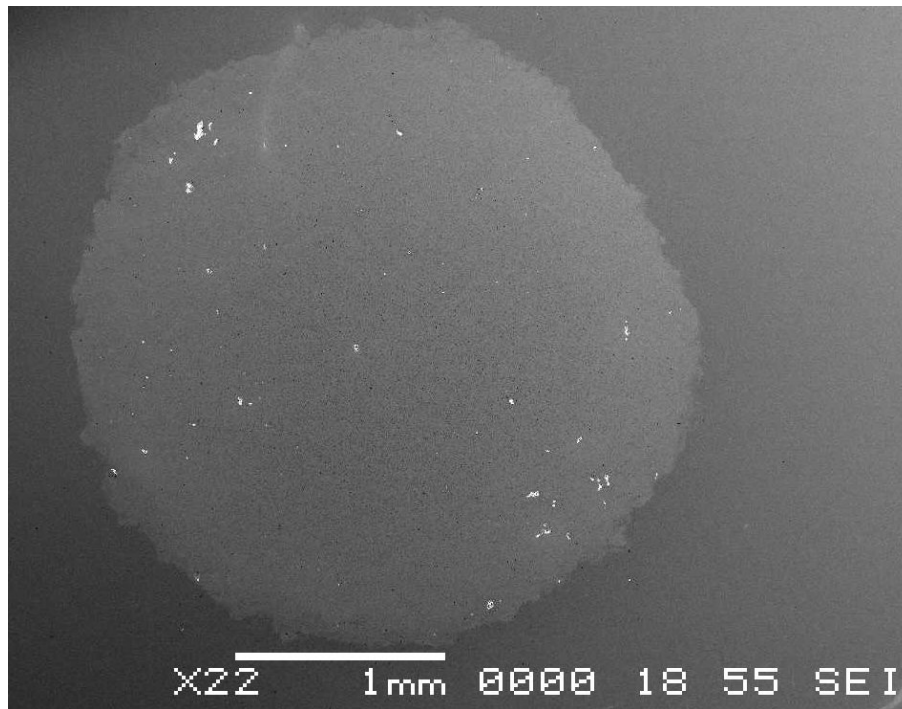
Figure 12. SEM micrograph of the surface of condition 4 after ESD repair (magnified 22×).

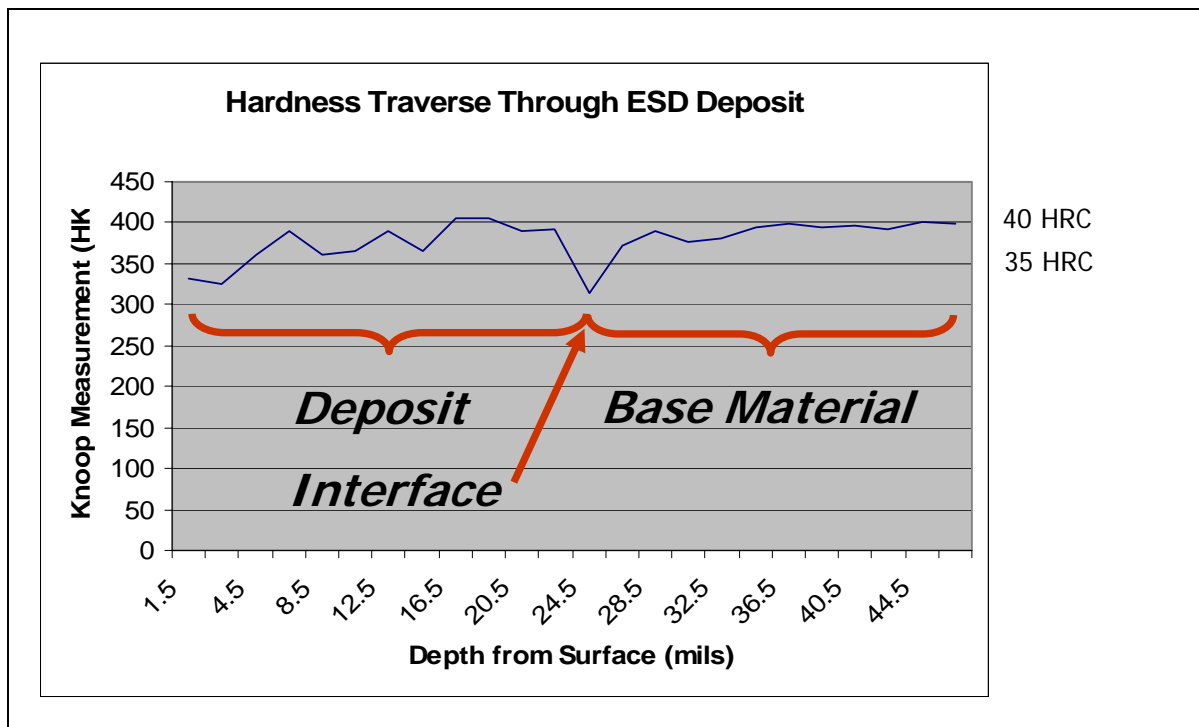
The Knoop microhardness scale (with a major load of 500 gmf) was utilized to assess the hardness of the deposit and the substrate, even though it has been shown that the ESD process has little to no deleterious effect on the substrate.⁴ The substrate was AISI 9310 steel heat treated to a hardness of ~40 HRC, as the results in table 3 show. The hardness of the deposit and the base metal was essentially the same. In addition, the hardness of the base metal was not altered as a result of the ESD process. Figure 20 shows a graph of the hardness data, and figure 21 includes a micrograph of the hardness indents through the deposit into the base metal.

Figure 20. Plot of hardness through ESD into the base metal, showing similar hardness values.

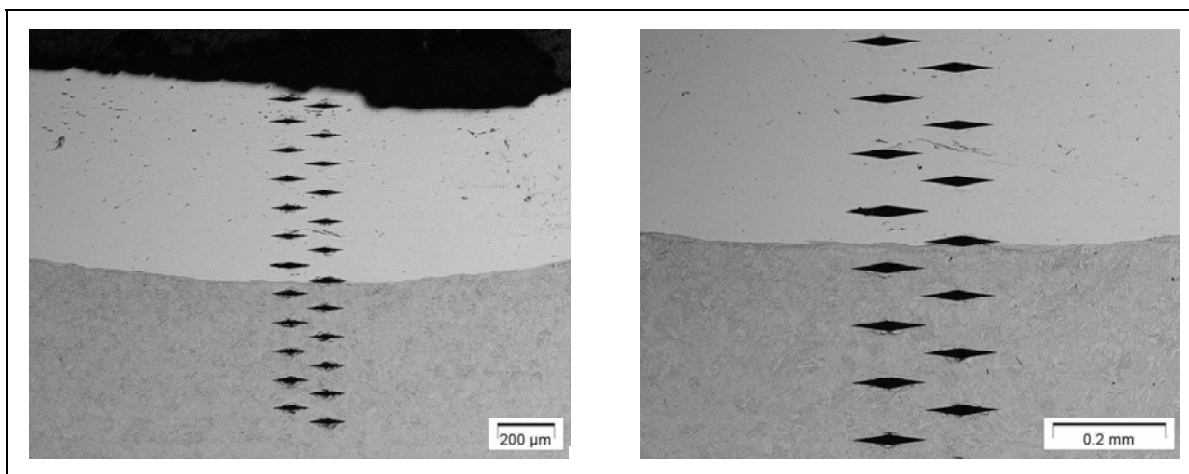
Figure 21. Micrographs of Knoop microhardness indents through the ESD into the base metal. Base metal etched with 2% nital (magnified 50× [left] and 100× [right]).
